MEMORANDUM

Date: 12/8/2021
To: Whom it May Concern
From: Wilson & Girgenti, LLC
RE: Boca Royale Golf and Country Club
1601 Englewood Rd. Englewood, FL 34223

Please see attached report outlining our findings during our site visit on November 9th 2021. It provides detailed explanations of the existing conditions of the electrical, mechanical, plumbing and fire protection systems for the 18,000 square foot golf and country club located at 1601 Englewood Rd, Englewood FL 4223.

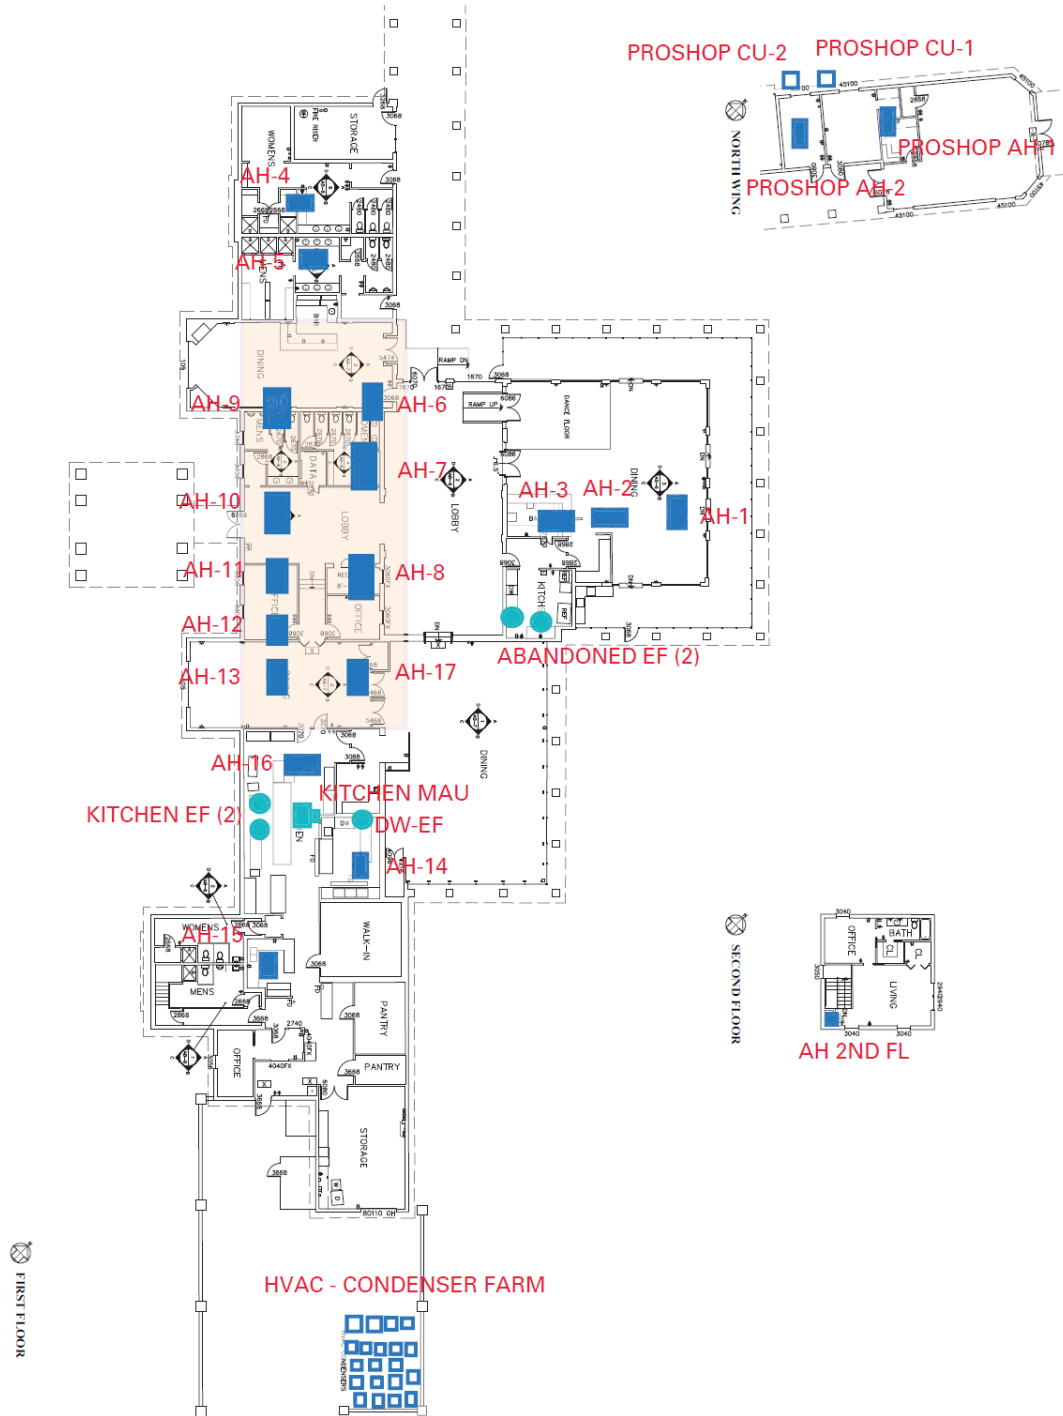
Image 1 – HVAC Unit Locations

Below explains a summary of the findings during the site visit. A more detailed explanation per unit can be found below on Table 1 with locations shown on Image 1.

<u>WAREHOUSE ROOFTOP UNITS</u>	<u>MFR</u>	<u>MODEL #</u>	<u>TONS</u>	<u>YEAR</u>	<u>REMARKS</u>
Proshop AH/CU 1	TRANE	XE1000 (TTR042D1)	3.5	2000	R22 REFRIGERANT, WE HAD NO ACCESS TO AIR HANDLER, CONDENSING UNIT LOCATED NORTH. UNIT OVER 20 YEARS OLD
Proshop AH/CU 2	TRANE	XB1000 (TTBD18C100A2)	1.5	2000	R22 REFRIGERANT, WE HAD NO ACCESS TO AIR HANDLER, CONDENSING UNIT LOCATED NORTH. UNIT OVER 20 YEARS OLD
CU/AH #1	CU: AMERICAN STANDARD / AH: TRANE	CU: 2TTR3060A1000AA / AH: 4TE3F65B1000BA	5	CU: 2007 / AH: 2011	R410A REFRIGERANT, OUTSIDE AIR OPEN ENDED RECONNECT TO RETURN DUCTWORK, SOME FLEX DUCT WORK IS REUSABLE, REMOVE ABANDONED DUCTWORK
DINING CU/AH #2	AMERISTAR	CU: M4AC4060C1000AA / AH: M4H3060B1000AA	5	2017	R410A REFRIGERANT, AIR HANDLER CABINET IS MOLDY, OUTSIDE AIR CONNECTION OPEN, RETURN DUCTWORK IS NOT REUSABLE (MAIN DUCTWORK IS UNINSULATED), REMOVE ABANDONED DUCTWORK
DINING CU/AH #3	YORK	CU: YCE60B21SA / AH: AE60CBD22G	5	-	R410A REFRIGERANT, MOISTURE SEEN ON UNINSULATED DUCTWORK CAUSING RUST/MOLD

WOMENS RR CU/AH #4	GOODMAN	CU : GSX130301BC / AH: ARUF30B14AC	2.5	-	R410A REFRIGERANT, OUTSIDE AIR / EXHAUST NOT SEALED PROPERLY, MODLY RETURN DUCTOWRK, DRAIN PAN VERY RUSTY

MENS RR CU/AH #5	GOODMAN	CU: G8X130421BC / AH: ARUF42C14AD	3.5	2014	R410A REFRIGERANT, FLEX SUPPLY IN GOOD CONDITION, REMOVE ABANDONED DUCTWORK. MAIN DUCTWORK IN GOOD CONDITION
CU/AH #6	TRANE	CU: 4TTB3048D1000B / AH: TAM4A0C48S41SBA	4	2012	R410A REFRIGERANT
CU/AH #7	AMERISTAR	CU: M4AC4060C1000AA / AH: M4AH30660B1000A A	5	2017	R410A REFRIGERANT, OLD INSULATION
CU/AH #8	TRANE	CU: 2TTR3060A / AH: TWE065E13FB2	5	2006	R22 REFRIGERANT, OPEN OUTSIDE AIR CONNECTION
CU/AH #9	RHEEM	CU: RA1436AJINA / AH: RH1P3617STANIA	3	2016	R410A REFRIGERANT, DUCTWORK NEEDS TO BE REPLACED
CU/AH #10	CU: YORK / AH: JOHNSON CONTROLS	CU: YCE36B22SA / AH: AP36BX21C	3	-	R410A REFRIGERANT, SHORT HARD DUCTWORK WITH FLEX SPIDER DUCTWORK. REPLACE MAIN TRUNKLINE
CU/AH #11	AMERISTAR	CU: M4AC4036C1000AA / AH: M4AH036A1000AA	3	2017	R410A REFRIGERANT, MOLDY UNINSULATED SUPPLY AND RETURN TO BE REAPLCED

CU/AH #12	AMERISTAR	CU: M4AC4060C1000AA / AH: M4AH3060B1000AA	5	CU: 2017 / AH: 2016	R410A REFRIGERANT, MOLDY FLEX DUCTWORK TO BE REPLACED
CU/AH #13	TRANE	CU: TTR060D1100A0 / AH: TWE060C15FD0	5	2001	R22 REFRIGERANT, CONDESATE LINE IS NOT CONNECTED, SPIDER FLEX DUCTWORK, MOLDY DUCTWORK SUPPLY AND RETURN MAINS
CU/AH #14	YORK	CU: YCE48B21SA / AH: AP48CBC21C	4	-	R410A REFRIGERANT DUCTWORK IN GOOD CONDITION
SE KITCHEN & RR CU/AH #15	TRANE (AMERICAN STANDARD)	CU1: 2TTA3060A3000AA / CU2: 2TTR / AH:TWE120B100EL	CU: (2) 5 / AH: 10	2006	R22 REFRIGERANT, DUCTWORK IN GOOD SHAPE, RUSTY DIFFUSERS
MAIN KITCHEN CU/AH #16	TRANE	CU: (2) 2TTA3060A3000A / AH: TWE120B100EL	CU: (2) 5 / AH: 10	2006	R22 REFRIGERANT, RUSTY DIFFUSERS, CONDENSING UNIT HAS EXPOSED REFRIGERANT PIPING, CORED UNDERGROUND TOO CLOSE TO DISCONNECT
CU/AH #17	TRANE	CU: 2TTR1048A1000AA / AH: TEC3F48B100AA	4	2009	R22 REFRIGERANT, MOLDY CABINET, SUPPLY AND RETURN DUCTWORK TO BE REPLACED.

CU/AH 2ND FLOOR	JOHNSON CONTROLS	CU: YCE30B22SA / AH: AP30BBB21C	2.5	-	LIMITED TO NO ACCES TO THE UNIT
